INSPECTION REPORT

For the Property at:
52 BOON AVENUE
TORONTO, ON M6E 3Z3

Prepared for: ROGER TRAVASSOS and MEL KELLY
Inspection Date: Sunday, February 18, 2024
Prepared by: Tim Palmer

RE: Report No. 2740
52 Boon Avenue
Toronto, ON
M6E 3Z3

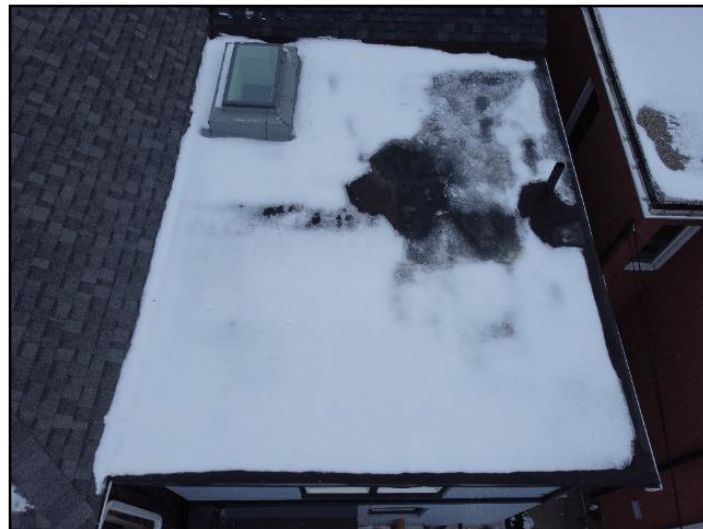
1. Condition: • Due to excess snow and ice coverage on roof, we recommend a full roof inspection when roof is clear by a qualified roofer.

1. Due to excess snow and ice coverage on roof...

Task: Further evaluation by a certified Contractor

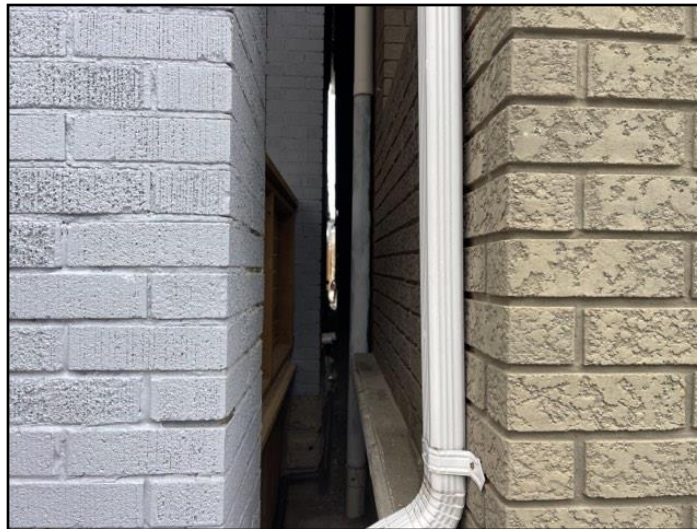
- Inaccessible wall

2. Inaccessible wall

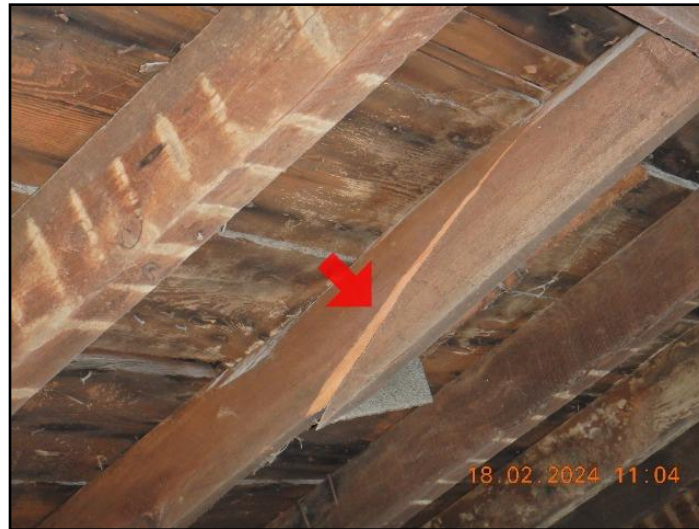
4. **Condition:** • [Split](#)

Implication(s): Weakened structure | Chance of structural movement

3. Split

Task: Repair

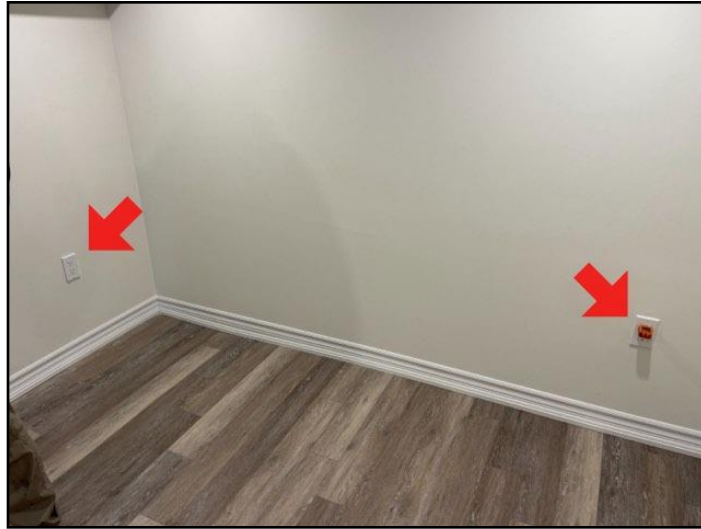
5. Condition: • [Inoperative](#)

Implication(s): Equipment inoperative

Location: Front Basement

4. Inoperative

Task: Further evaluation by a certified Contractor

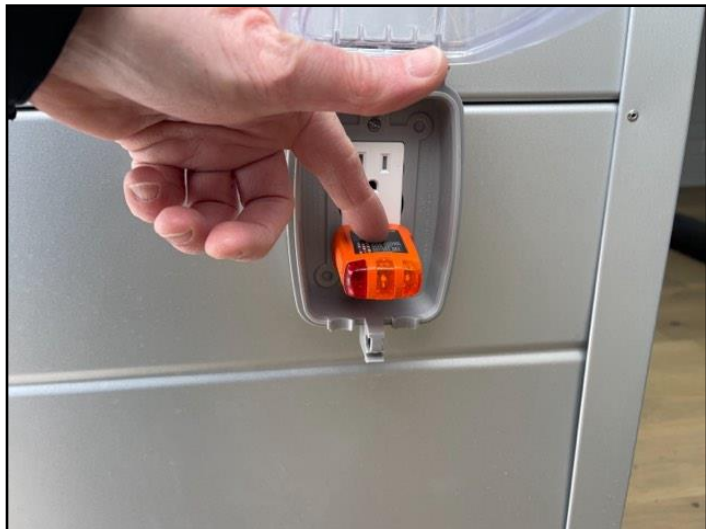
6. Condition: • [GFCI/GFI needed \(Ground Fault Circuit Interrupter\)](#)

Implication(s): Electric shock

Location: Rear Exterior

5. GFCI/GFI needed (Ground Fault Circuit...

Task: Consult a qualified professional

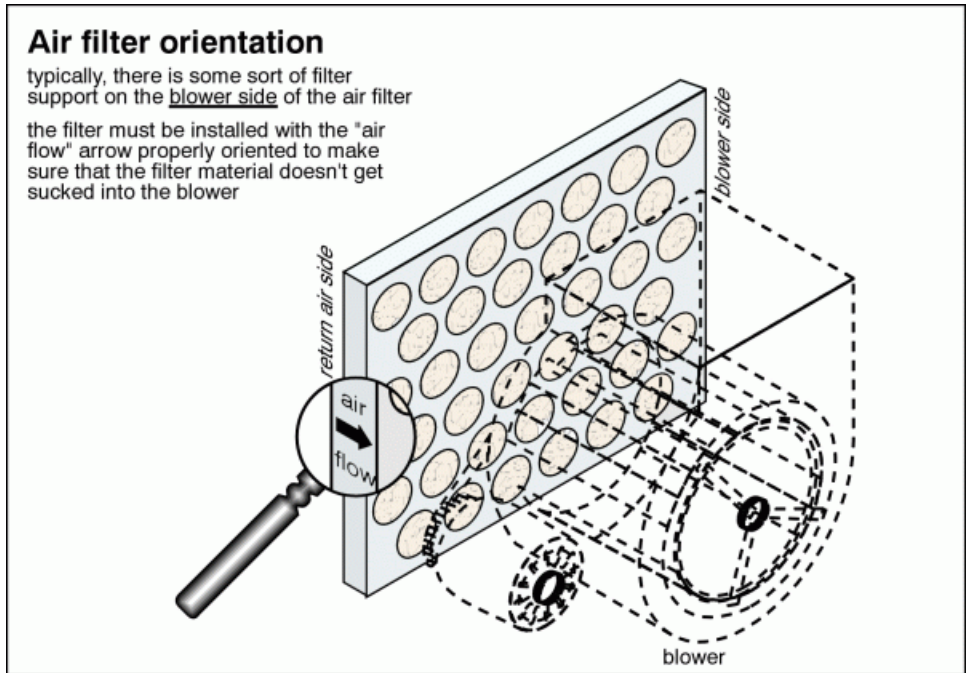
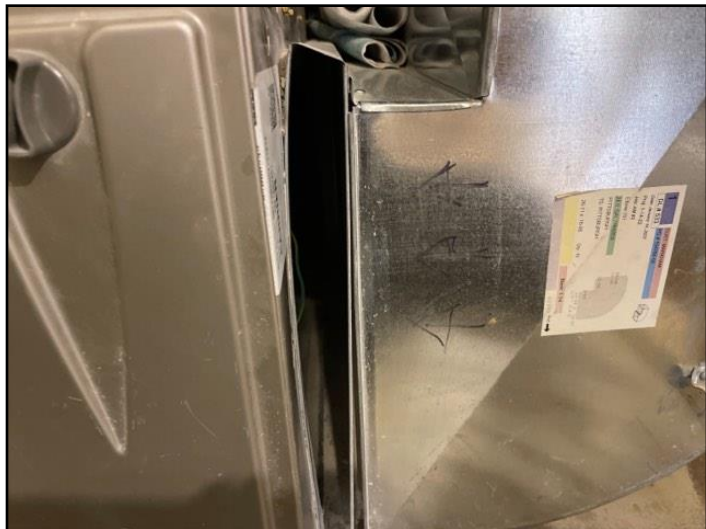
7. Condition: • [Missing](#)

Implication(s): Increased heating costs | Reduced comfort | Increased maintenance costs

7. Missing

Task: Provide

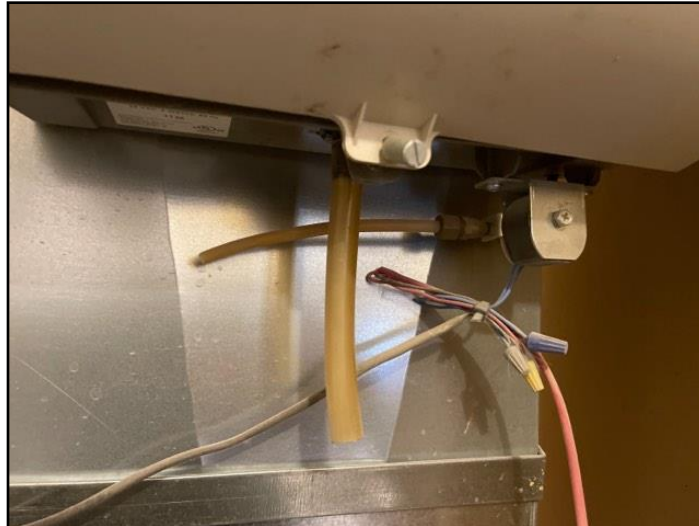
8. Condition: • [Inoperative motor or solenoid valve](#)

Implication(s): Equipment inoperative

Location: Furnace Room

8. Inoperative motor or solenoid valve

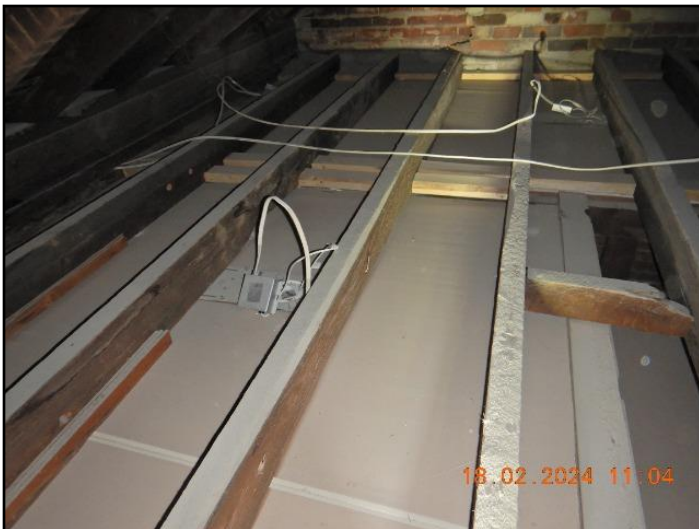
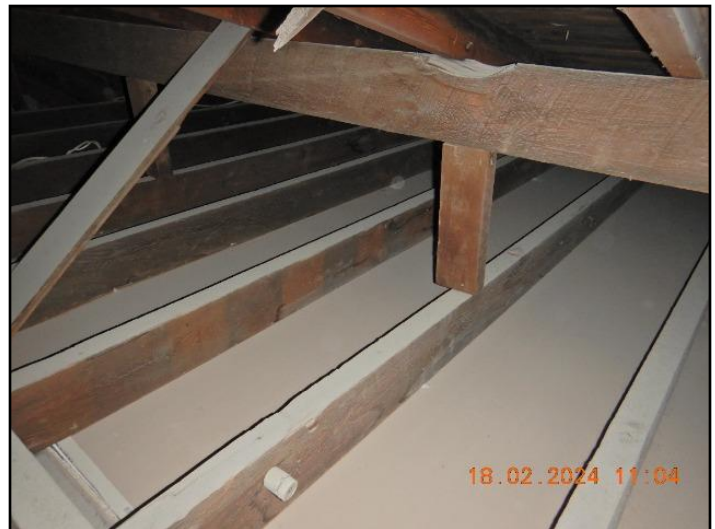
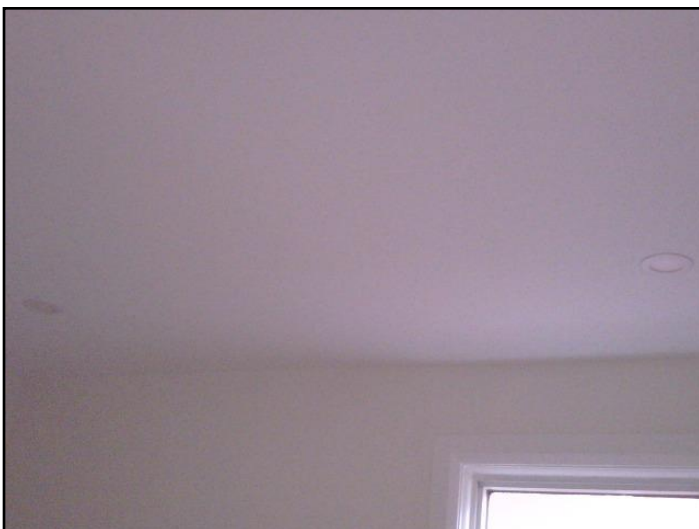
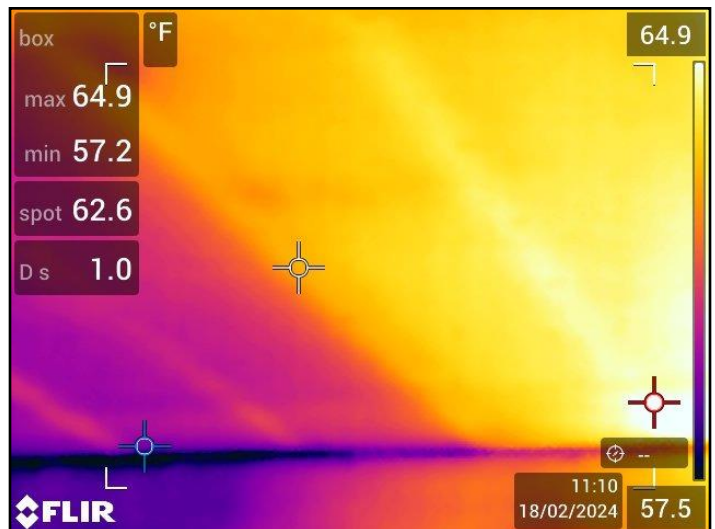
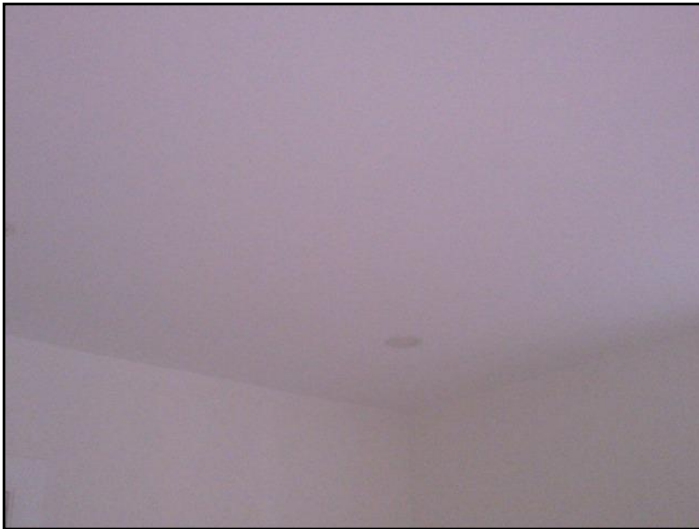
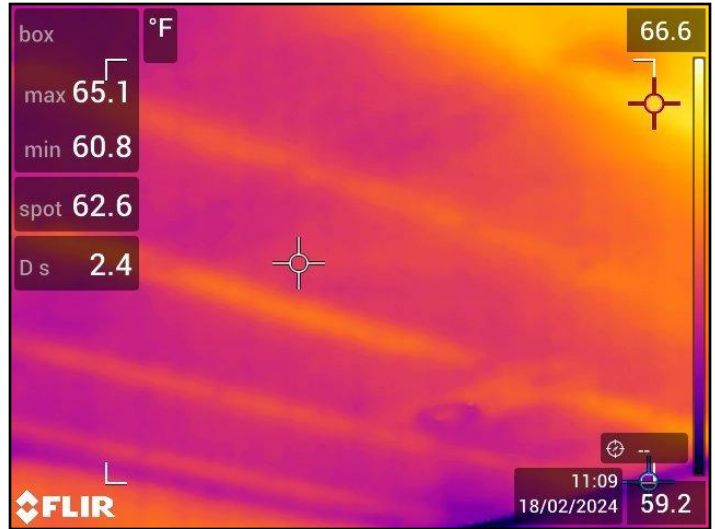
9. Condition: • [Amount inadequate](#)

None noted in Gable roof area,
Flat roof area not determined (further evaluation recommended)

Implication(s): Increased heating and cooling costs

13. Amount inadequate

14. Amount inadequate

15. None noted

16. None noted

Task: Provide

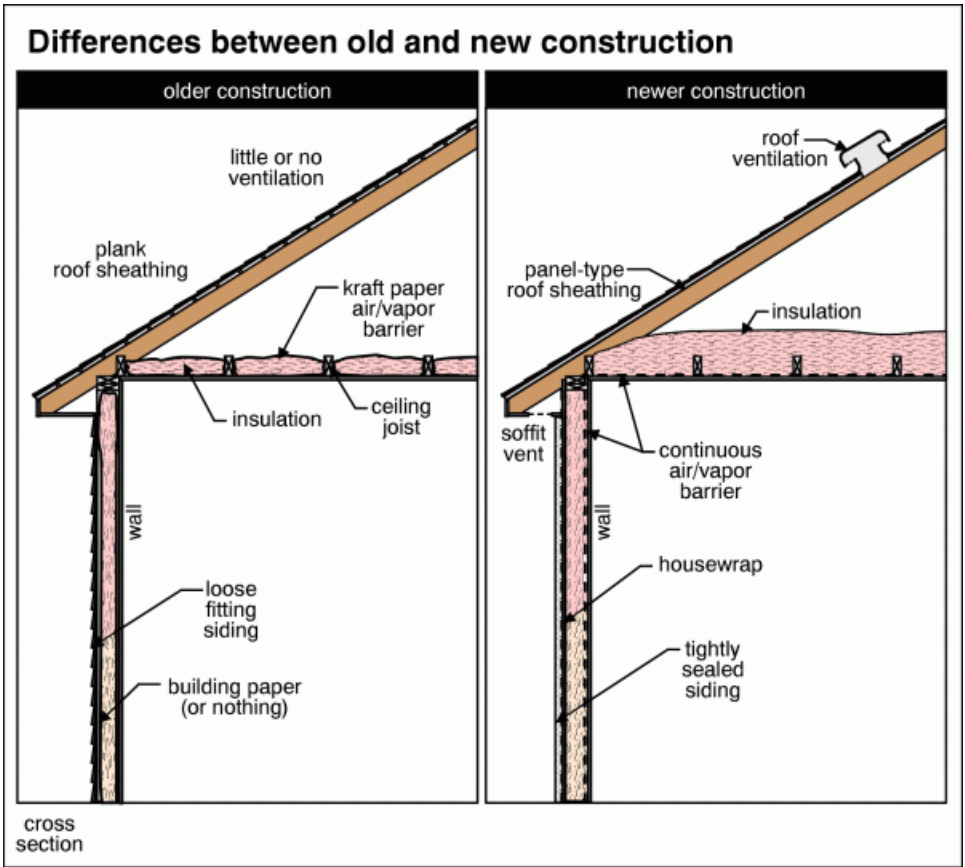
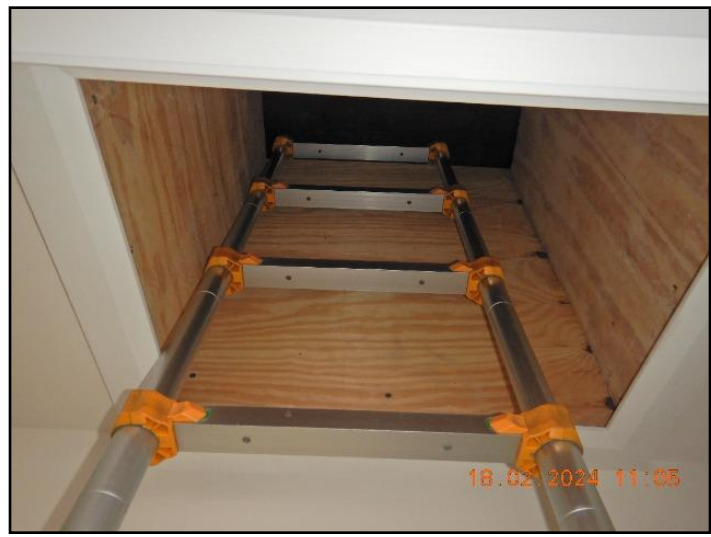
10. Condition: • [Missing](#)

Implication(s): Chance of condensation damage to finishes and/or structure | Increased heating and cooling costs | Reduced comfort

21. Missing

Task: Provide

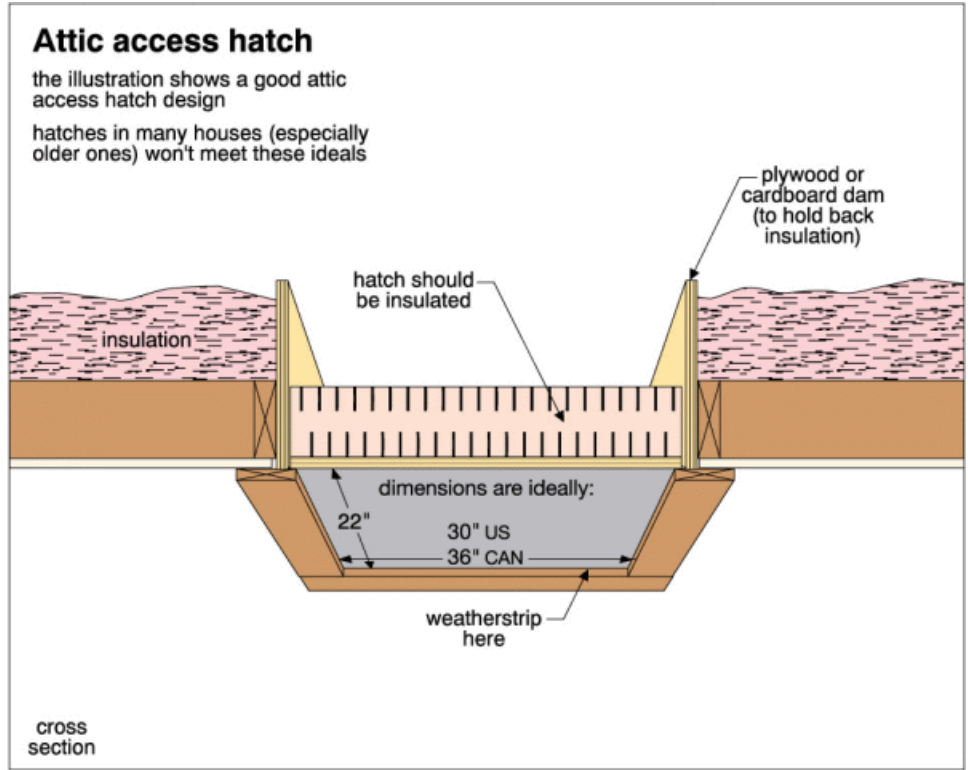
11. Condition: • [Not insulated and not weatherstripped](#)

Implication(s): Chance of condensation damage to finishes and/or structure | Increased heating and cooling costs | Reduced comfort

Task: Improve
Time: Immediate

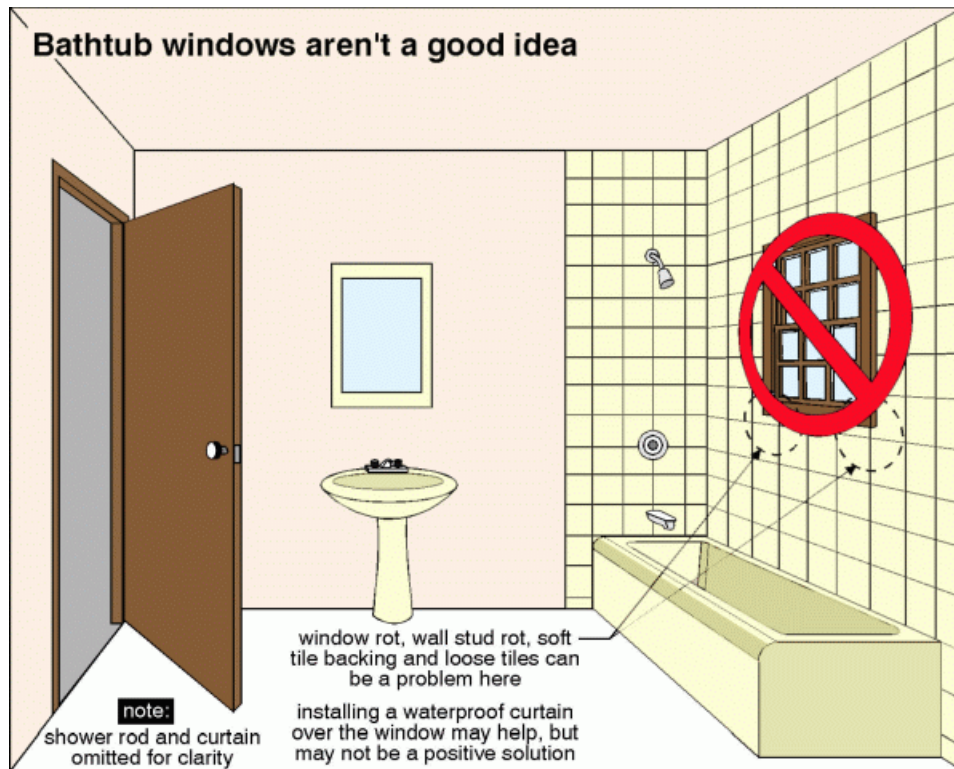
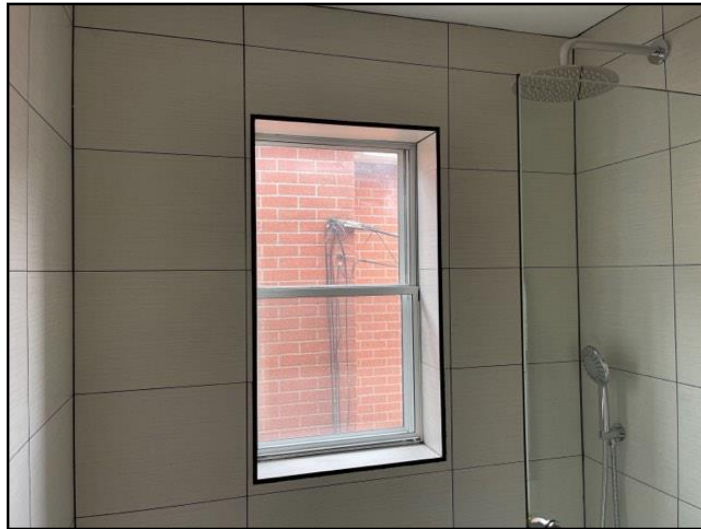
13. **Condition:** • [Unprotected window](#)

Implication(s): Chance of damage to finishes and structure

22. Unprotected window

Task: Improve

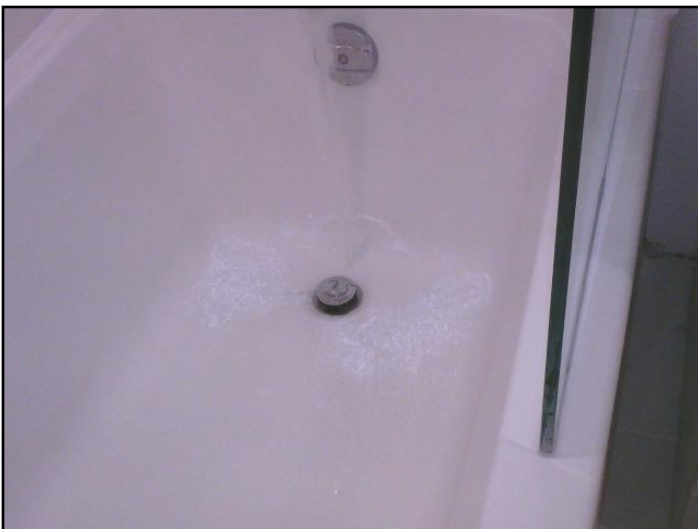
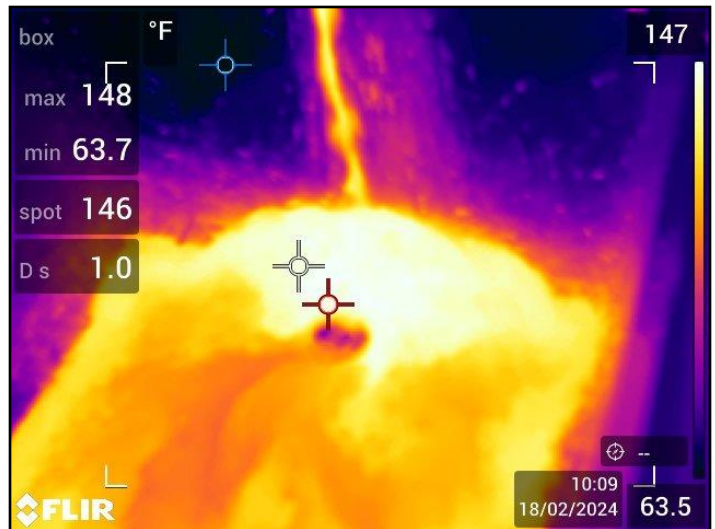
- Water heater typical life expectancy:** • 10 to 15 years
- Water heater failure probability:** • [Low](#)
- Hot water temperature (Generally accepted safe temp. is 120° F):**
 - More than 145° F

25. More than 145° F

26. More than 145° F

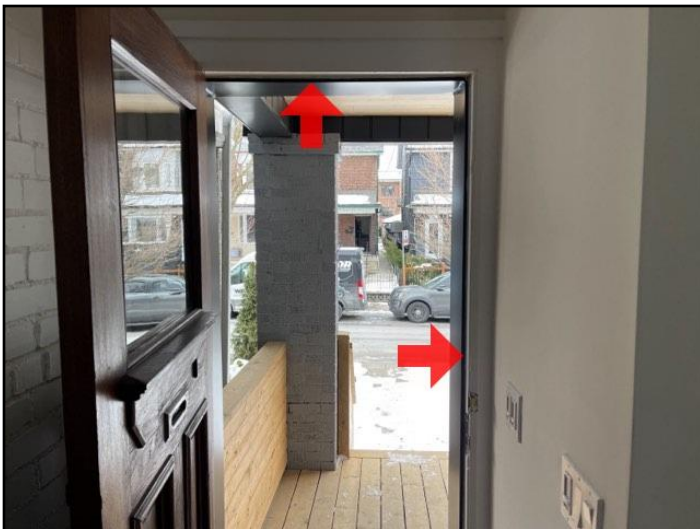
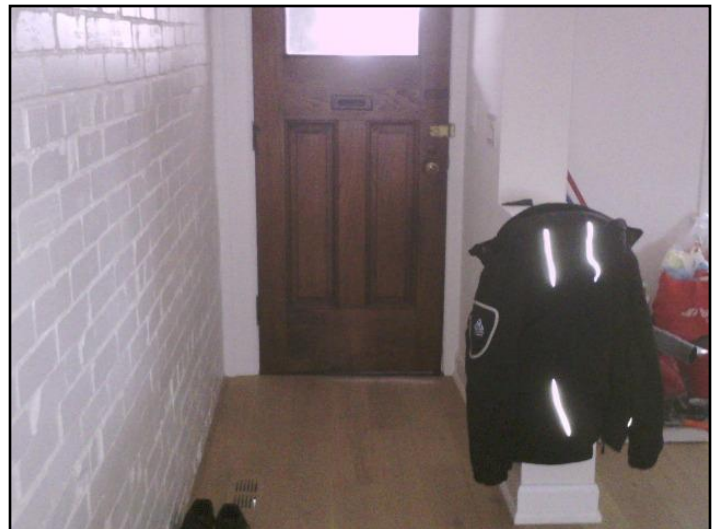
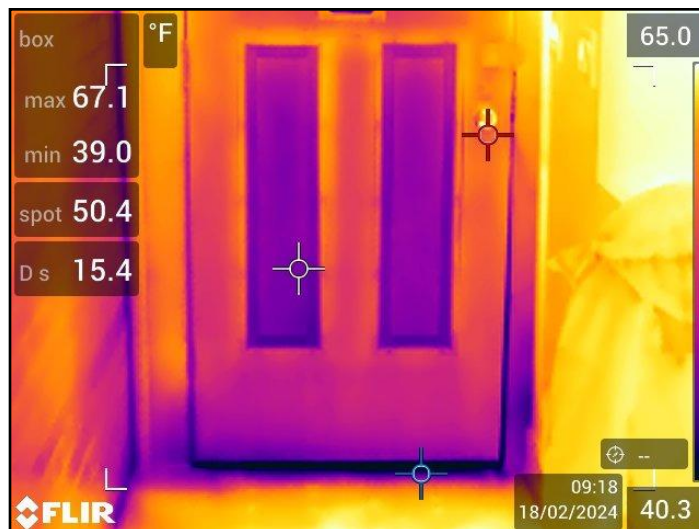
15. Condition: • [Weatherstripping missing or ineffective](#)

28. Weatherstripping missing or ineffective

29. Weatherstripping missing or ineffective

30. Weatherstripping missing or ineffective

Task: Provide

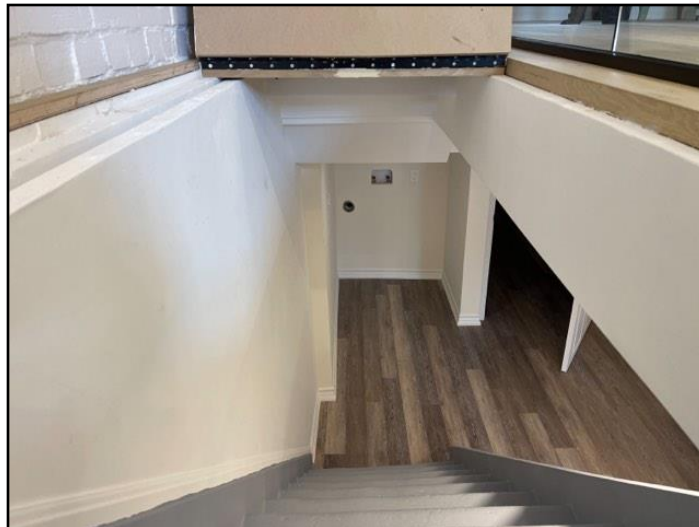
16. Condition: • [Headroom less than ideal](#)

31. Headroom less than ideal

Task: Further evaluation

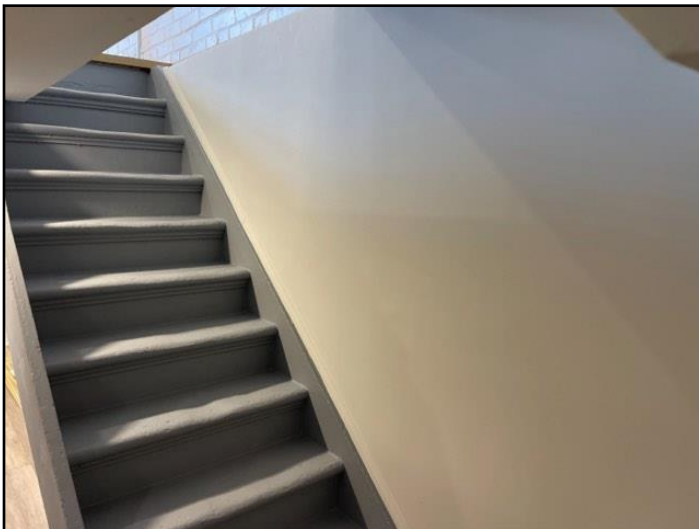
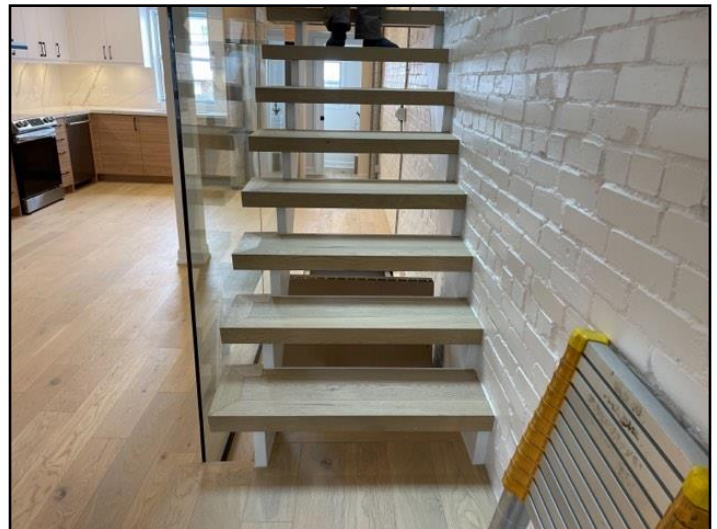
17. Condition: • [Missing](#)

Implication(s): Fall hazard

32. Missing

33. Missing
